Renovair

Explorative study on the quality of the indoor environment in buildings after (energy-efficient) renovations

Final Report

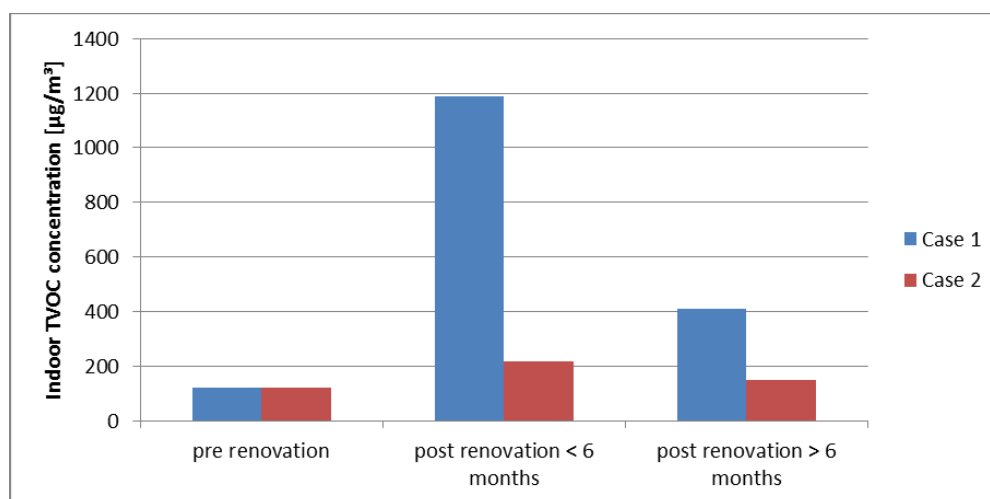
Figure 8 Indoor TVOC concentration decay after wall treatment against rising damp

A more detailed analysis of 18 indoor VOCs, quantified by means of passive samplers, doesn't highlight the increase of any of these organic compounds.

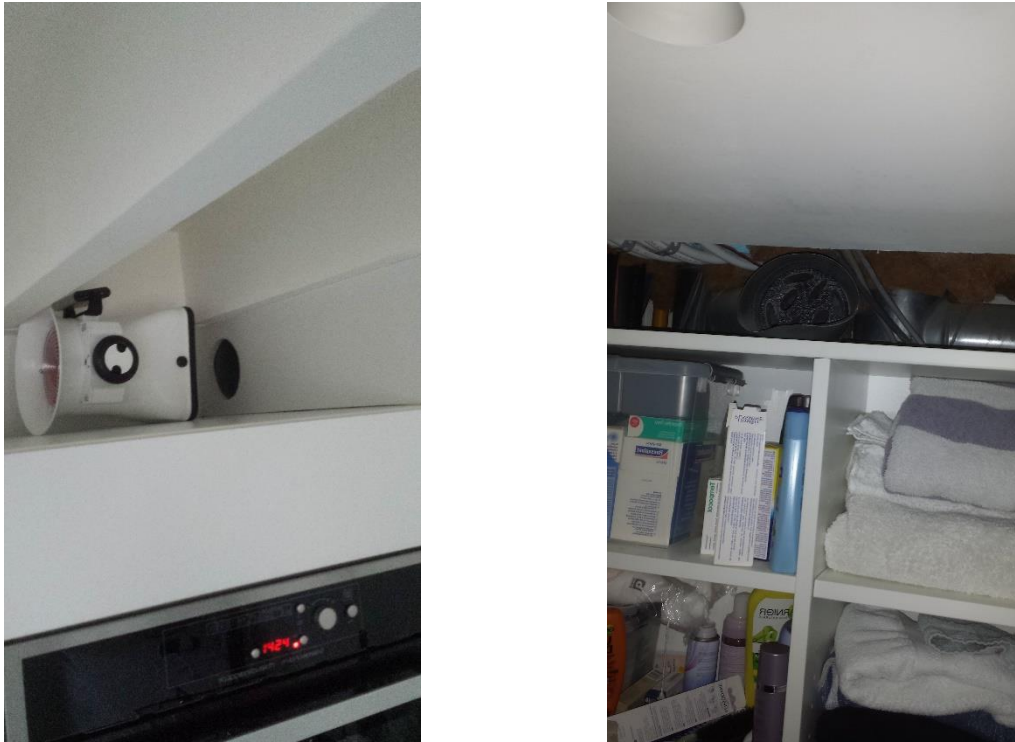
Figure 10: Sometimes the supply or exhaust outlet was difficult to access, leading to errors in the measurement of the air flow rate.

In general, except for Case 3, the measured air flow rates are more or less in accordance with the requirements. In Case 3 they are far below the requirements and have virtually no impact on the airflow in the dwelling.

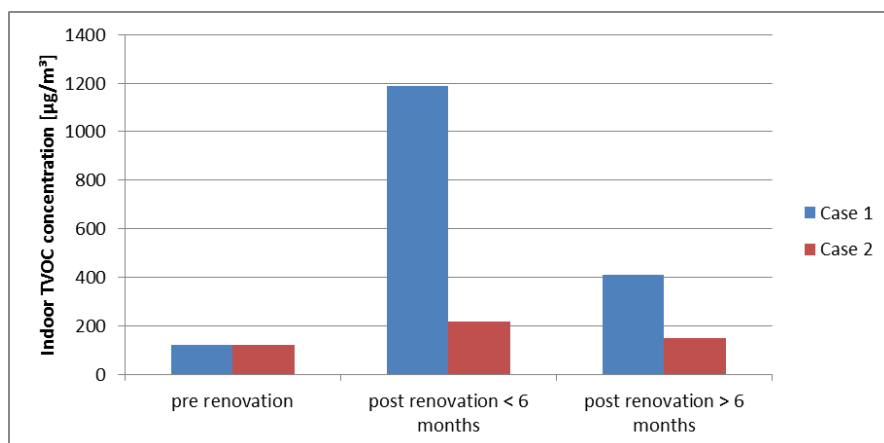
Figuur: TVOC concentratie in het binnenklimaat bij het injecteren van muren tegen opstijgend vocht

AANDA CHT	De verhoging van de concentratie aan TVOC na 6 maanden kan gedeeltelijk verklaard worden door organische stoffen die vrijkomen bij de injectie van muren tegen opstijgend vocht, zoals epoxysilicaan (door injecteren van epoxy hars). Deze pollutanten zijn minder vluchtig en blijven nog lange tijd (tot 1,5 jaar) in het binnenklimaat aanwezig, zelfs bij verluchten na de ingreep. Eerder onderzoek wijst uit dat de concentratie hoger is bij ingrepen waar de injectie niet afdoende was of niet correct werd uitgevoerd. In die situaties kunnen de concentraties oplopen tot een 10-voud van de normale omstandigheden.
--------------	---
